AFRL-SA-WP-SR-2015-0011

Composite Material Hazard Assessment at Crash Sites

January 2015

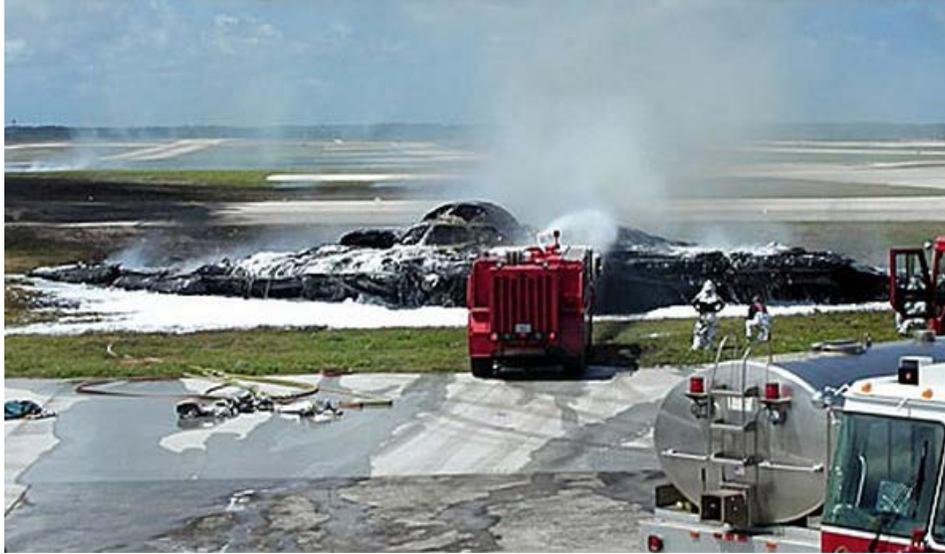
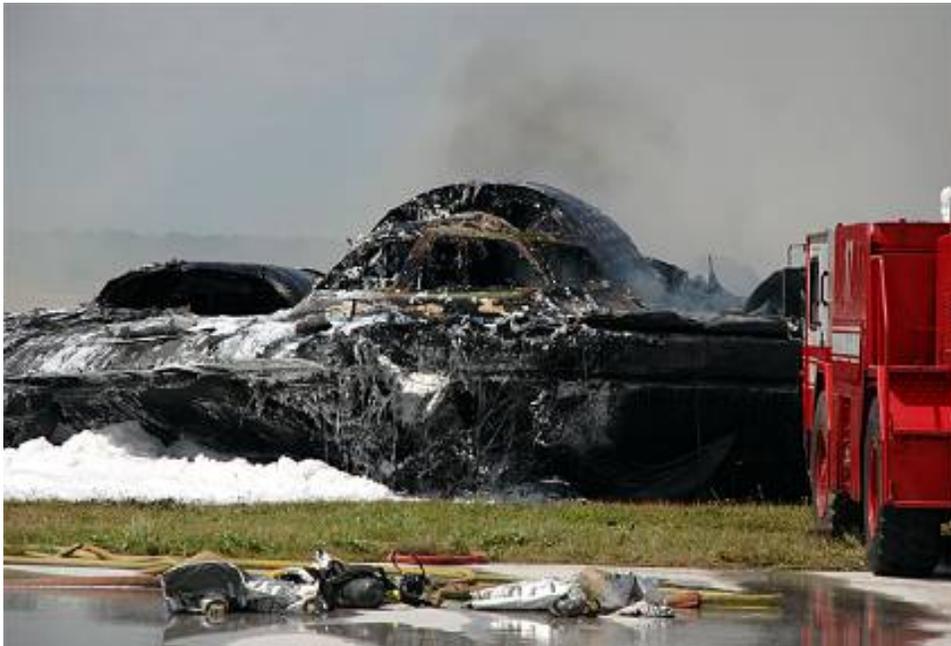
1. The following two pictures show the debris from the B-2A crash.

Initial ground contact occurred when the left wing tip hit the ground causing fracture damage to the wing tip and wing tip support structure. The aircraft continued upwind then descended to hit the ground with the nose gear and then the left main landing gear. Upon ground impact the left main landing gear separated from the aircraft releasing fuel. This caused a fireball to travel upwind scorching an area of approximately 29.517 m². The left main landing gear rested 475 m from the final position of the aircraft. The bomb bay and nose landing gear doors, located at 350-400 from the aircraft showed signs of physical damage with little or no scorch markings. Ground scars show the aircraft came to rest 717 m from initial ground contact. The pilot (left) seat rested 458 m from the aircraft. The co-pilot seat rested 431 m from the aircraft. The hatches were located 568 m and 578 m from the aircraft. The debris field was comprised of random pieces and fragments of composite materials ranging in size and shape with very few metal pieces found. Most of the aircraft structure remained intact but with severe impact damage as it came to rest on its bottom outer mold line. The survey determined the debris field area was 18,964 m².

The B-2A was designed with approximately 80% composite material and 20% aluminum and titanium as the substrate materials. The carbon fiber / epoxy composite system is the primary composite materials system; although there are other composite systems found in small quantities like fiberglass / PMR-15. JP-8 pool and fireballs can create flame temperatures in excess of 2000°F and “time at temperature” determines the degree of damage for these materials. As the flame-front penetrates through the composite thickness, layers burn and metals melt. The wreckage showed varying degrees of impact and thermal damage. The B-2A aircraft sustained severe thermal damage.

Aircraft materials show signs of thermal damage that help to determine what the temperatures could have been. Melting point, color change and recognition of surface feature changes were used to evaluate the wreckage. The following materials were used as indicators of temperature exposures: carbon fiber, glass, titanium, aluminum, silver, nickel, iron, copper, epoxy and polyurethane coatings, and polycarbonate. The inboard and outboard wing assembly wing tips, leading and trailing edge showed signs of thermal exposure of at least 1700°F. The crew station assembly showed signs of at least 1200-1500°F. The center body was at least 1200°F. The aft wing assembly, GLAS, hot trailing edge and decks were exposed to at least 900-1100°F. The bottom outer mold line condition will remain unknown until the wreckage is moved.

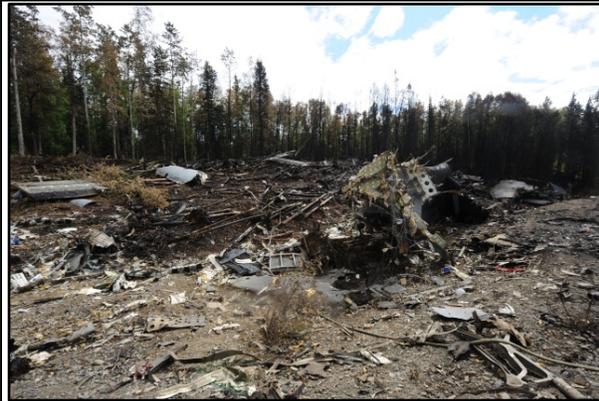
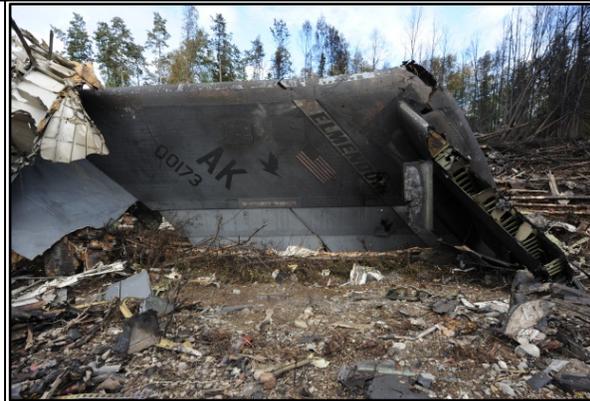
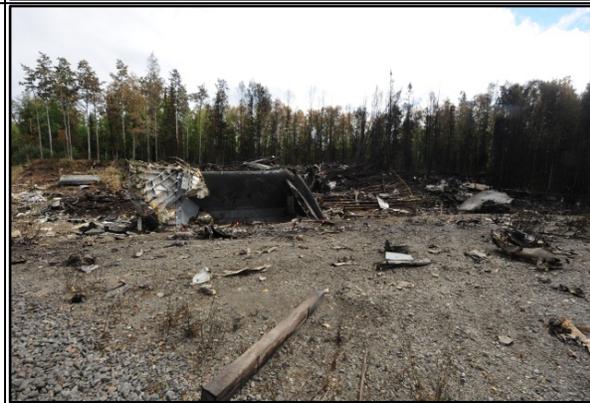
JOINT BASE ELMENDORF-RICHARDSON, AK

A C-17 aircraft from Elmendorf AFB, Alaska, crashed off base at a remote location on 28 July 2010. Firefighters sprayed a fixant solution of water and wax on any parts that appeared to be ACM. Due to the austere conditions and frequent rain, BEF collected no personal air samples; however, direct reading instruments (DRIs) measured particle and aerosol mass concentrations. A condensation particle counter and optical particle counter were the DRIs measured particle and aerosol mass concentrations, respectively [10]. Sampling continued for 3 days of crash site recovery operations in close proximity to workers who were engaged in cutting operations on the vertical and horizontal stabilizers of the aircraft. The average particulate mass concentration as measured by the DRIs over the 3 days was 1.71 mg/m³, which is less than USAFSAM's recommended OEEL for respirable particulate of 3.0 mg/m³. Measured concentrations reported for the DRIs include background ambient aerosol particulate, which would also include particulate from the diesel exhaust of an excavator and other equipment operating at the crash site. See Appendix B for pictures of the crash site.

-- The wreckage of a 3rd Wing C-17 that crashed shortly after take-off at about 6:14 p.m. (Alaska time) during a local training mission July 28, 2010.

-- The four crew members on board were killed in the crash (Air Force photos/Senior Airman Cynthia Spalding).
